TECHNICAL SERVICE BULLETIN

Subject: TSB-ECN151063 – New diode Added on Scrub Relays

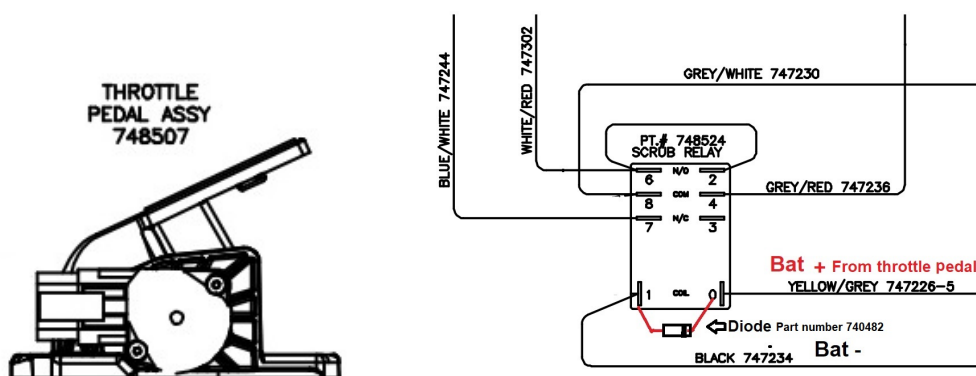
The scrub control relay may, in some cases cause damage to the switch inside the throttle pedal.

The diode added to the relay. The diode acts as surge protector for the switch, located inside the throttle pedal.

Reference Instructions – Order diode part number 740482 along with the throttle pedal 748507, when replacing, if the brush switch inside the throttle has failed.

For Installation Procedure. See below.
