TECHNICAL SERVICE BULLETIN

Subject: TSB for CABLE P/N 744617

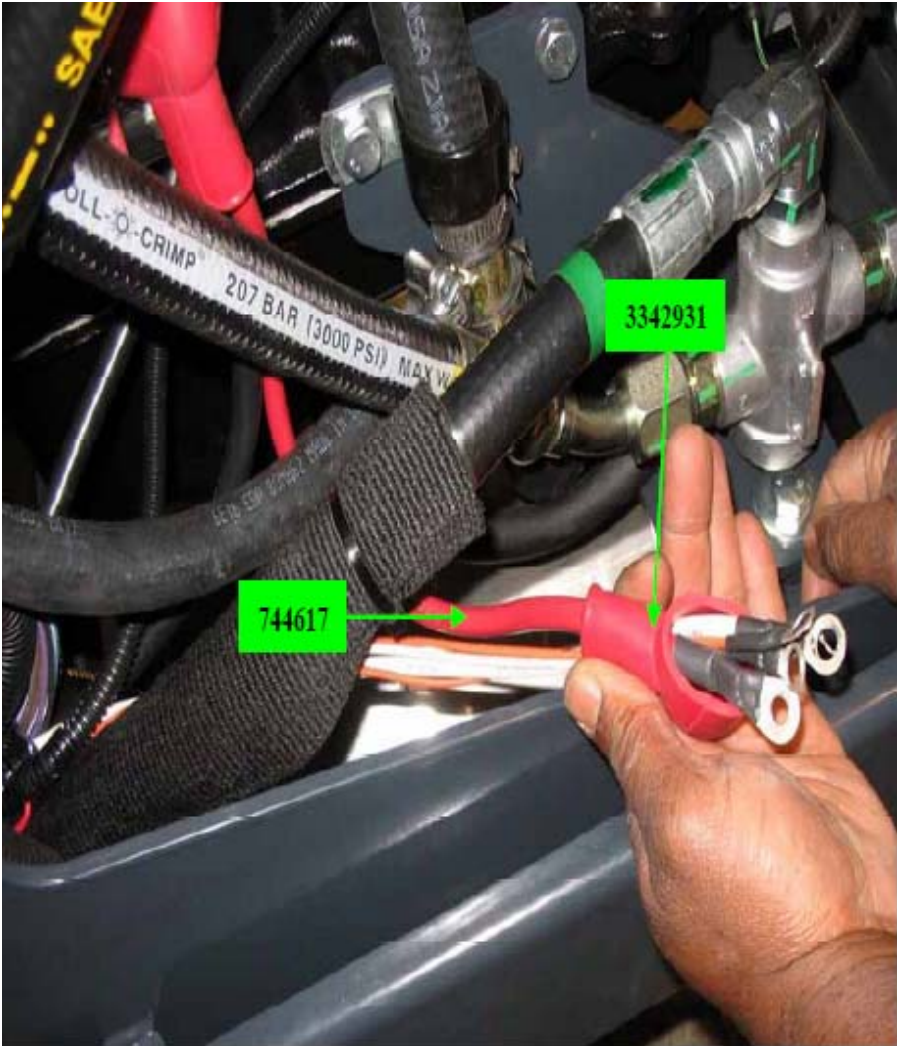
VIEW OF WIRES ROUTED THROUGH BOOT
