TECHNICAL SERVICE BULLETIN

Subject: GM Exhaust manifold gasket update

Models: All Monitors and Commanders with GM 1.6 engines

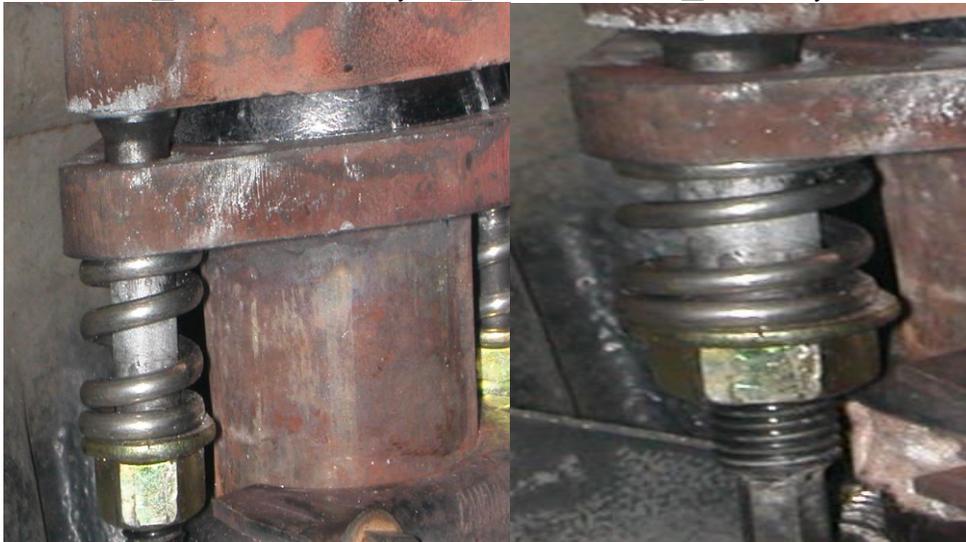
Improve the reliability of the donut gasket connection

Reference Kit Instructions – This is only to be done should existing nuts come loose or donut gasket fails. Parts and labor should be submitted through the warranty claim process.

Order and install part number (2) 3344568 (Bolt and Springs) and (1) 3343069 (Donut Gasket)

Remove old bolts and nuts, install new bolts, slide springs on the bolts, insert the donut gasket in the exhaust pipe. Align the pipe to the bolts with the spring between it and the engine manifold and tighten the nuts to the end of the threading on the bolt. Reference pictures below. Should you have any questions, feel free to contact Technical Support.
