TECHNICAL SERVICE BULLETIN

Subject: Possible failure of the heat exchanger on the Nautilus sweeper scrubber with the heated solution option installed. Serial numbers of machines affected: 21PB1232 to 22PB1622

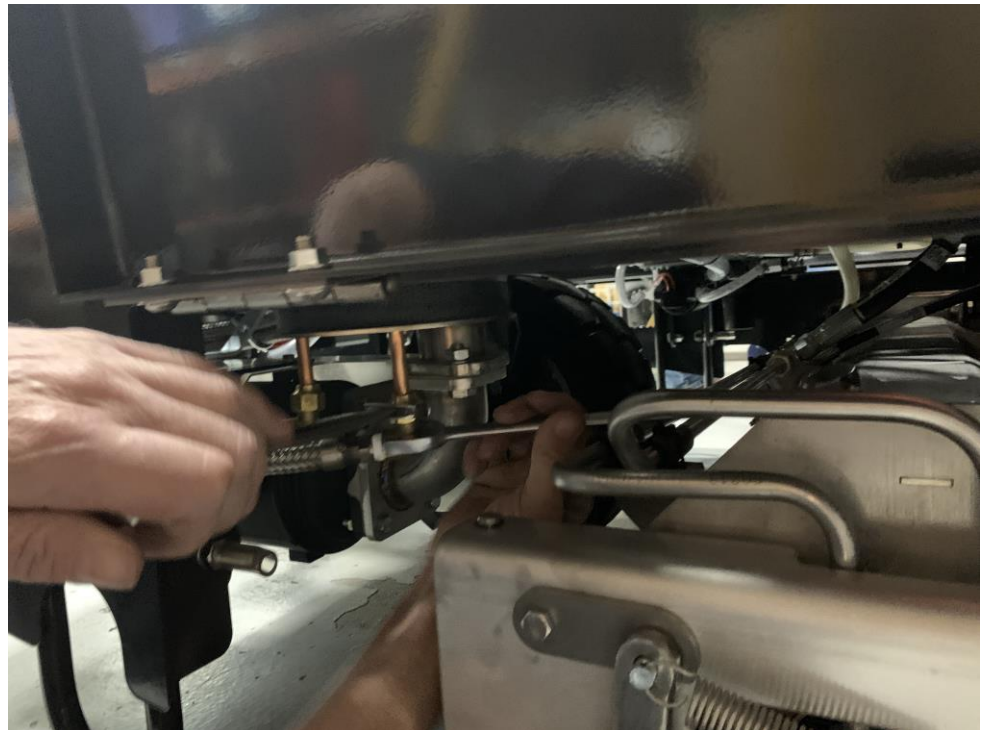
2. (continued)
Secure flare nut and
fitting when loosening:

Make sure to secure both the flare nut on the heat exchanger and the brass fitting with wrenches when loosening to prevent damage to the components.

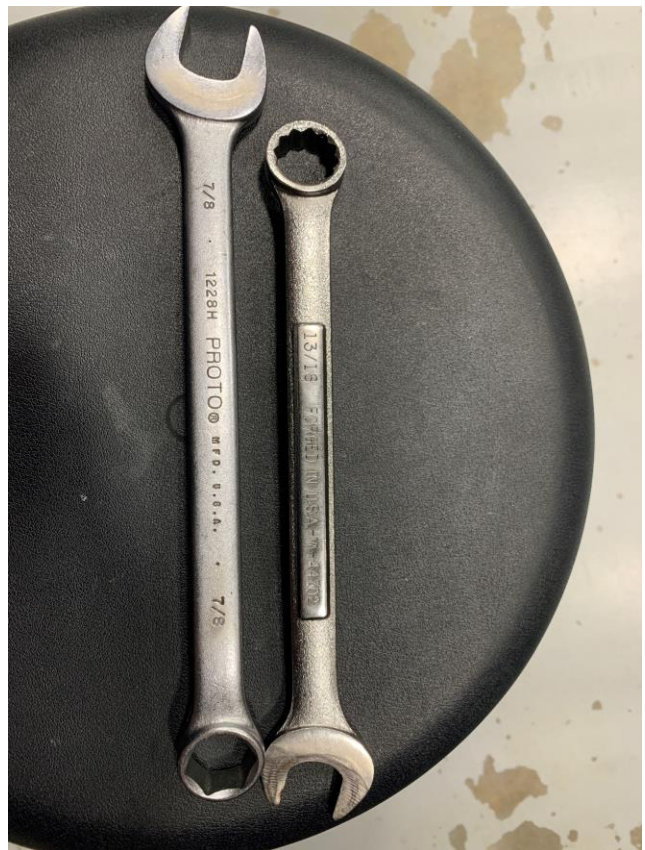
Use a 7/8 and 13/16 wrench to remove
fitting from heat exchanger:
