TECHNICAL SERVICE BULLETIN

Subject: TSB for CABLE P/N 744617

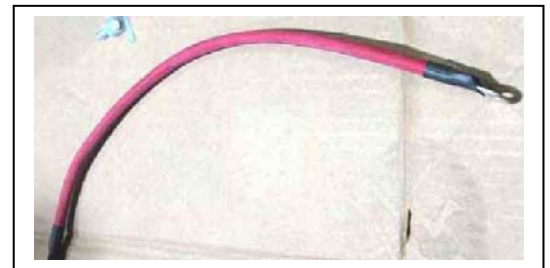
INCORRECT CABLE INSTALLED AT FACTORY MAY CAUSE DAMAGE TO WIRING

CORRECT CABLE GAUGE WILL ELIMINATE POSSIBLE DAMAGE. REMOVE AND REPLACE WITH NEW.
TIME ALLOCATED FOR CREDIT: ½ HOUR LABOR
