PRODUCT UPDATE

Subject: TSB for E14 Recovery Tank (part #2655-0114-0) and Recovery Lid (part #2655-0115-0)

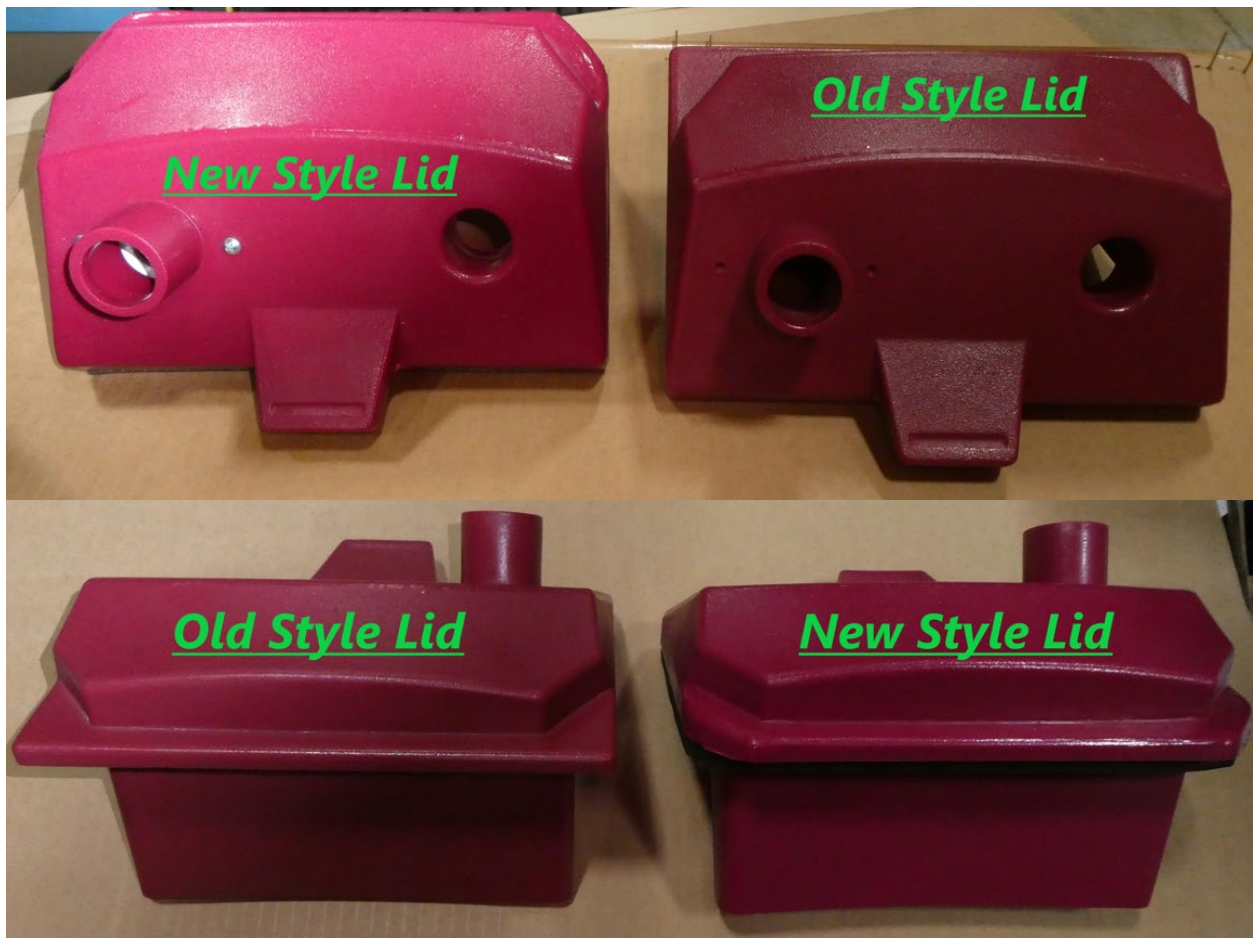
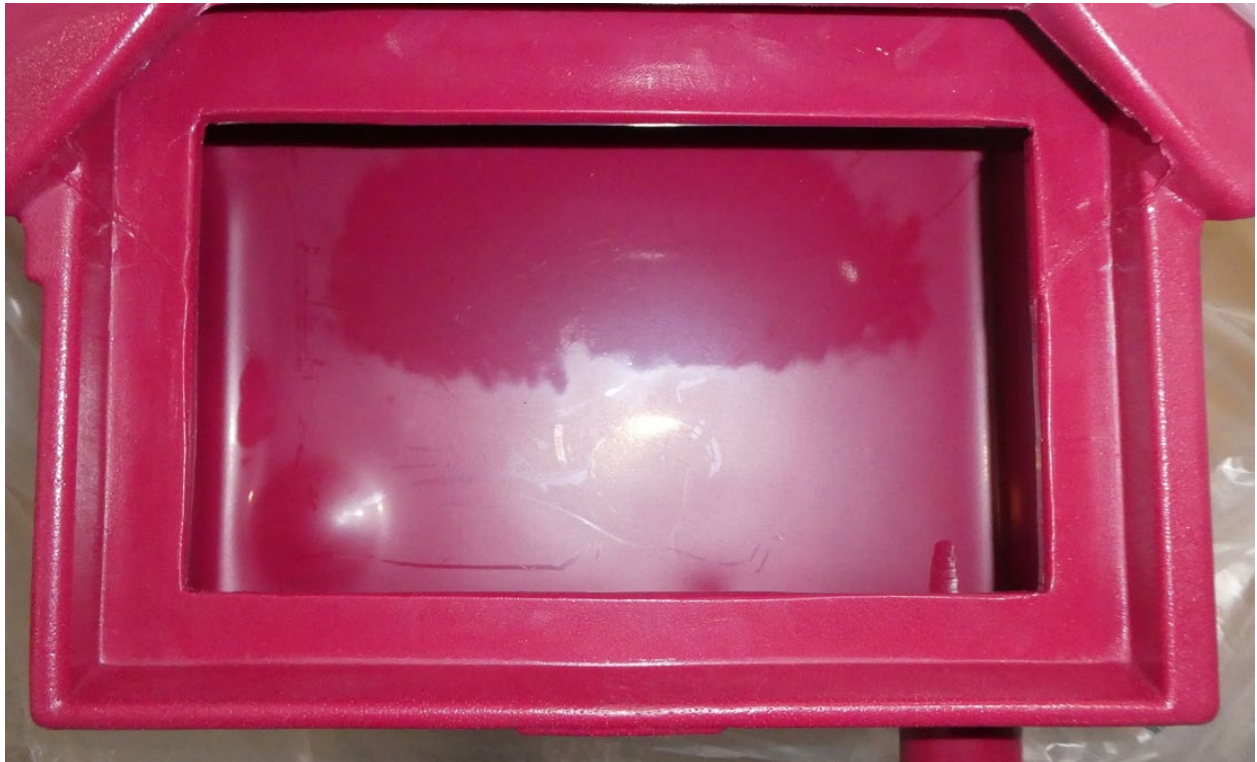
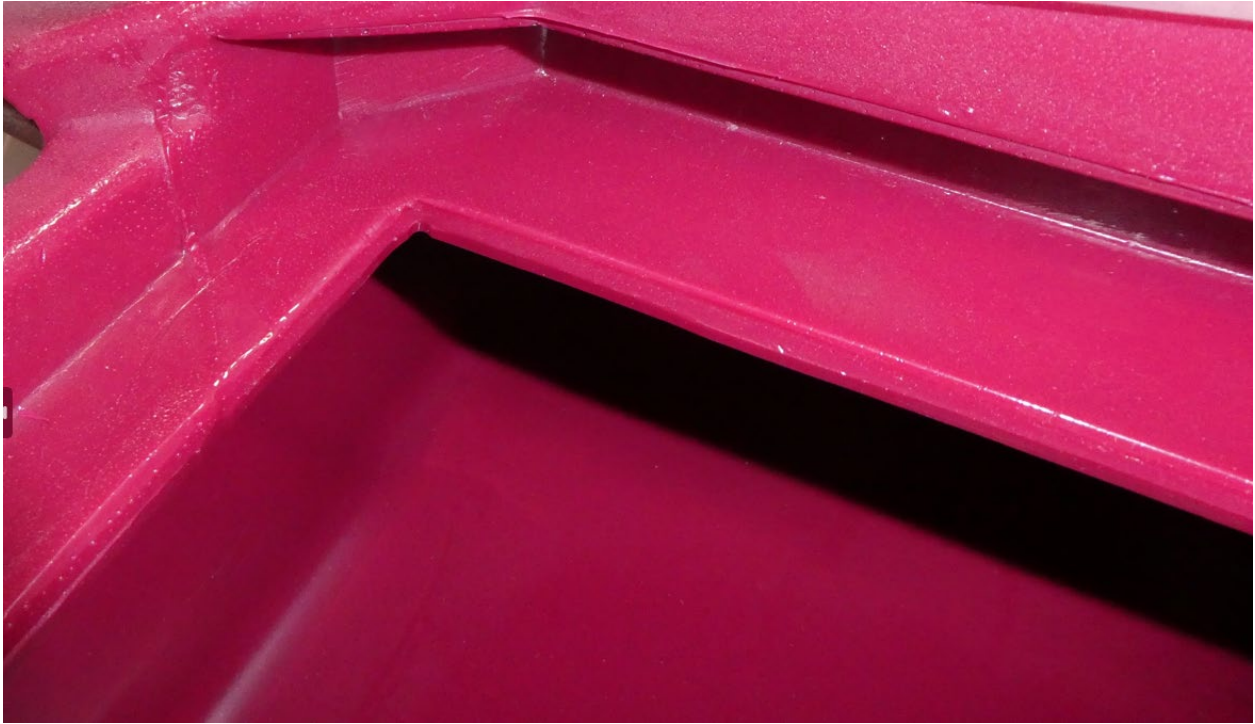
Both the Recovery Tank and Lid assembly have been remodeled from a straight fit design to a 45-degree angle design.

Old style lid will not fit new style Recovery Tank. When replacing either assembly, both need to be replaced as a whole (together)
