TECHNICAL SERVICE BULLETIN

Subject: TSB for 730939 Side Scrub Squeegee for Nautilus/HD equipped with Side Scrub Option

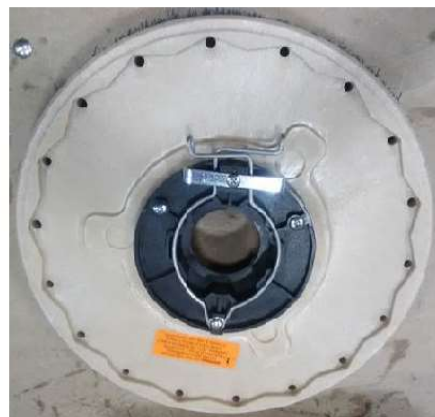
New Style Scrub Brush

The side squeegee has additional holes to accommodate the new style brush
